Reconstructed acid mine drainage system

Project: Acid mine drainage system remediation

Location: Springfield Township, Fayette County, Pa.

Scope: 10 acres site, four water treatment ponds and pipe network

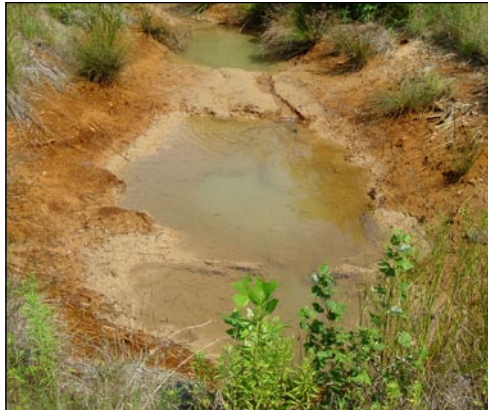
ABOVE: Laurel Mine pond. BELOW: Inflow shaft.

Berner Construction excavated a 100-foot-long channel between the first two sediment ponds. Effluent fills the first pond and overflows a bank on one end, filling up the limestone-lined channel. The second pond is effectively divided into thirds by two limestone baffles constructed on two concrete weirs; as the pond fills up, effluent flows over the baffles and is treated for iron hydroxide contamination and acidity by the pond's limestone a second time.
